A Study on Barriers in the Existing 200 Years Old Institutional Building at Adayar, Chennai & Proposing Suitable Repair & Rehabilitation Technique for Rectification

S.Vignesh¹, L.Sabarigirivasan²Department of Civil Engineering, SRM University Chennai, India,¹²

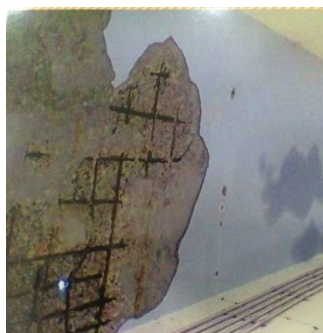
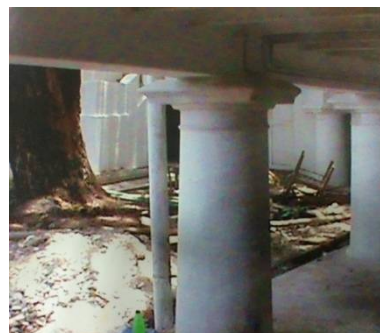
Since the building was very old and located in a marine climate, the water leakages and reinforcement corrosion were major issues[5]. There were leakages in the roof and water seepage through the external walls. The walls were made of laterite stone block masonry. The pointings of the stone masonry were disintegrated and water was leaking through these joints. There were spalling of plaster, cracks in the masonry walls and also cracks in the ceilings of the RCC roof. The water seepages and leakages led to growth of fungus and mosses on the walls and the ceilings. The corrosion of reinforcement led to spalling of concrete. There were cracks in the RCC ceilings and columns.

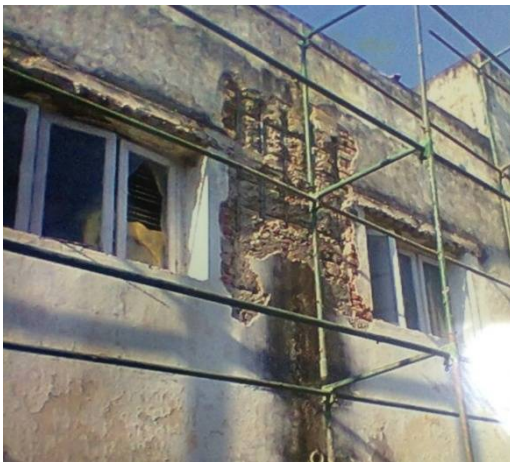
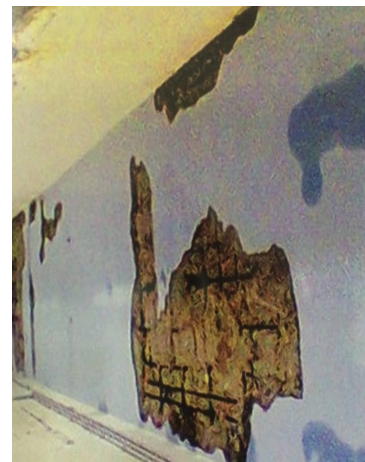
There were some cracks in the masonry walls. At those locations the plastering was chipped off and cutting of V-grooves were made along the length of the crack by chiselling[6]. The cleaning was made by a high pressure water jet. A wire mesh was fixed along the cracks after which the cracks were repaired with medium structural grade repair mortar.
