A Case Study for Recent Unsteability of Tidal River Banks in Pathar Pratima Island Located in Subdarban

¹Debabrata Pramanik, ²Biswajit Chakraborty, ³Tridipta Das

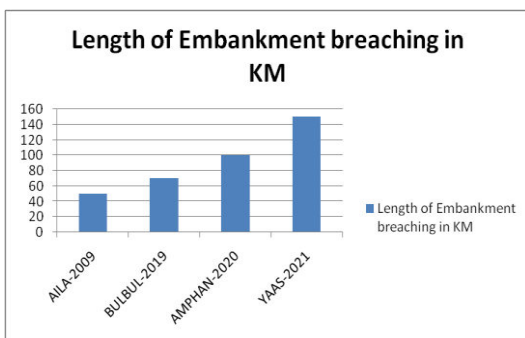
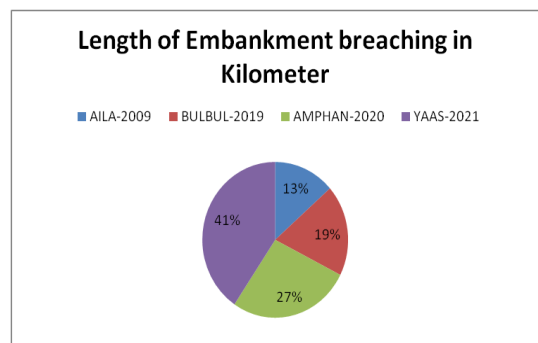
NATURAL HAZARDS AND CYCLONIC EFFECT:- In Patharpratima block It is seen 09 out of 15 GPs of Patharpratima block in the South 24 Parganas district have been identified to have potentially weak embankments due to natural shocks and fishery problems. The most vulnerable GPs Banashyamnagar, Brajaballavpur, Purnachandrapur, Patharpratima, Sridharnagar, Herombagopalpur and G-Plot. During the Aila cyclone in May (25-26), 2009 nearly 50 km of the total embankment of Patharpratima block were completely destroyed. The saline water caused heavy damage to agricultural field, fish farm and other man made structure (The Hindu 27may,2009). In 2019 near about 70 km of total embankment was destroyed due to cyclone 'BULBUL' whereas in 2020 super cyclone 'AMPHAN' made a total destruction of embankment near about 100 km. But recently in 2021 cyclone 'YAAS' near about 150 km of total embankment in Patharpratima block has been destructed.

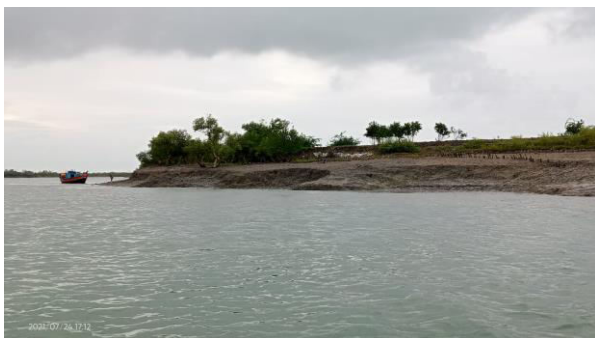
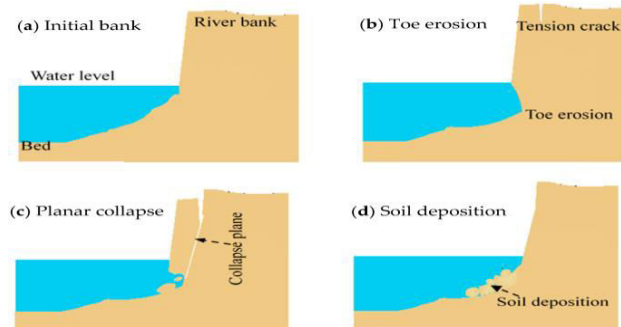
Toe and Lateral erosion Effects:- All river banks in Patharpratima block are mainly eroded by two major processes of bank erosion namely i) Toe erosion due to scour, ii) Lateral erosion. Because of scour depth near the bank increases and after certain time toe is eroded in such a way that the river bank becomes into a cantilever beam like structure. After forming cantilever beam like structure river bank collapses into the river due to gravity.

In the above picture river bank of Mridanga vanga river near Ramganga Getty is vulnerable. Near about 800 meter river bank is unstable due to several causes and one of the vital causes is River bank erosion with tidal wave effect. Bank

height of that particular area is about 4 meter from the water level where as during high tide water level rises almost 3 meters and during low tide water level goes down nearly 4 meter from the base water level. During high and low tide river bank experiences dry and wet behavior and because of that a shrinkage and expansion occurs in the bank materials. As the material is non-cohesive in category and due to this consecutive effect bank materials becomes loosen and ultimately wash out into the river.

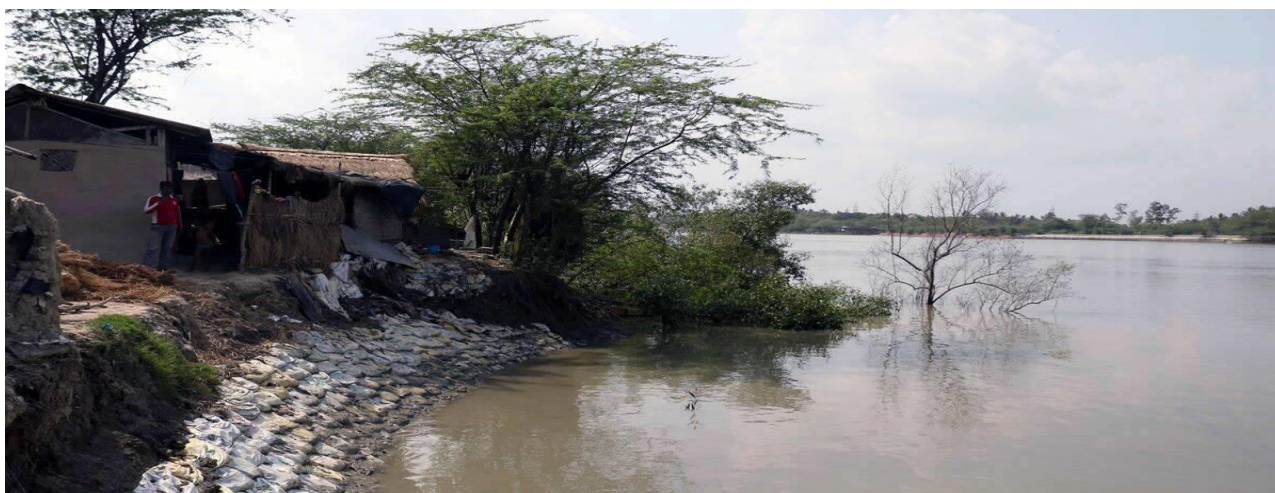
Source: Photo captured by authors near Mridangabhanga River

MAN MADE EFFECT:- Nobody can prevent natural hazards but when man become hazards then it becomes unstoppable and uncontrolled situation for living hood. All we know that deforestation plays crucial role in river bank erosion and river bank un-stabilities but here are some man made causes that we have seen in this study and effect of which ultimately breaches the river bank.

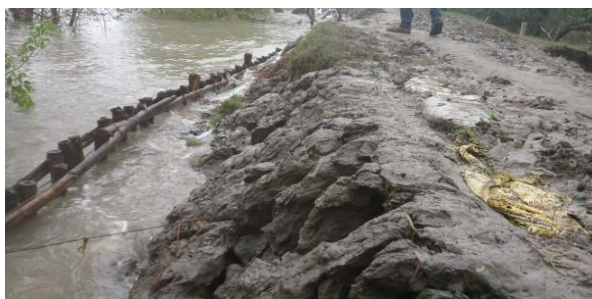
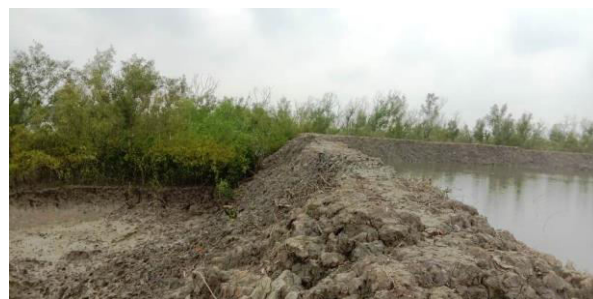
Fish Farming Pond Near To the Bank: - Along the river side the prawn seed collectors trample upon the mud base embankment and this causes soil erosion. So causes of embankment breaching are multidimensional. This is from natural as well as anthropogenic factors. Sometimes they build up fisheries just close to the river bank and deforest nearby trees. They made a channel to feed the saline water into their fishing pond and throw back the used pesticide mixed water into the river. During high tide water level of river is more and water level of fishing pond is less and pressure difference occurs and because of this river bank experiences force towards fishing pond. But during low tide water level is low compared to fishing pond because of this effect river bank experiences adverse effects and experiences force from pond to the river direction. When this phenomenon occurs for a period of time river bank loses its strength. For this nonscientific channel construction ultimately river bank is converted into un-stable one.
