Health Assessment of Structures

IV. AUDIT REPORT

The structure surveyed is an institutional building of MGM college of engineering and Technology, Navi Mumbai, Maharashtra. The structure is a G+5 RCC framed structure with a partial trussed roof on the 3rd floor. The building was constructed in stages with the ground floor completing construction in 1991 and subsequent floors being added in 1994, 1998, 2010, 2016 and 2019. In the absence of structural details and drawings, it is being assumed that the building has been adequately designed and constructed for its present level of usage. The building has been inspected on a room by room basis. Certain portions are covered by false ceiling, thus preventing visual inspection. Some minor repairs have been carried out on the ground and first floor. Recently, jacketing of columns surrounding the central courtyard was undertaken while the 5th floor was being constructed as they were heavily deteriorated. Also, all classrooms have been repainted as is gathered during the inspection.

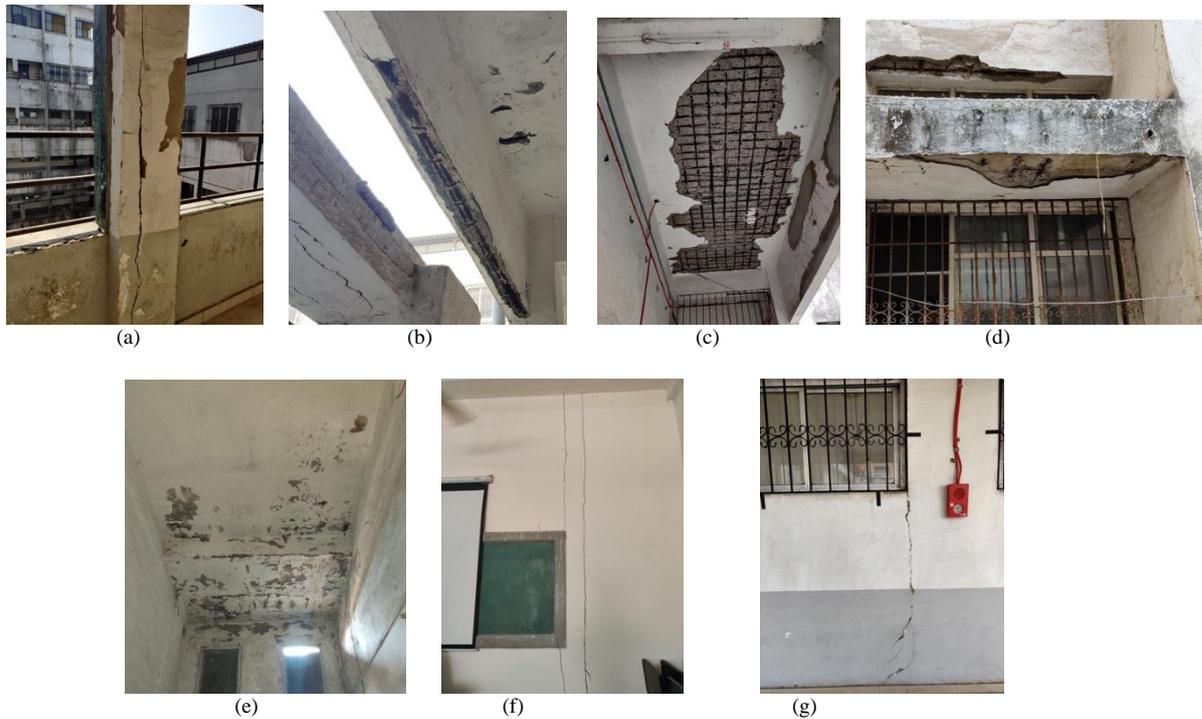
- 1) Many columns surrounding the central courtyard show wide longitudinal cracks. This is due to corrosion of rebar caused by inadequate protection provided to the lapping reinforcement for columns left for constructing further extensions.

- 2) Beams and corridor slabs surrounding the central courtyard show spalling of cover concrete. This is again due to corrosion of rebar as a result of non-provision of waterproofing layers during construction which led to water ingress in these members.

- 3) Some RCC Chajjas show excessive deflection and spalling of concrete. This is due to corrosion of the embedded rebar resulting in reduction in its strength.

- 4) A lot of spots having water marks have been noted in the corridor slabs, external walls and WC slabs. This indicates dampness due to inadequate waterproofing provided on these surfaces.

- 5) Termite infestation has been noted in the north west corner of the building.
- 6) Some walls show large separation cracks at joints of columns and walls.

Fig. 2. Visual observations (a) Splitting of columns (b) Spalling of cover concrete in beams (c) Spalling of cover concrete in slabs (d) Deterioration of RCC chajjas (e) Dampness in WC slab (f) Termite infestation (g) Separation cracks between wall and column

- 1) Each column is to be treated differently on the basis of the classification of the damage that has been noted during the visual inspection. For major cracks continuing throughout the length of the column, Jacketing should be done to restore its strength using micro concrete. For columns showing minor cracks, the old concrete should be removed, rust on the rebar should be scraped off using a wire brush, an effective rust passivator must be applied and the patch should be sealed by polymer modified mortar. Additional rebar, if necessary, must be added.

- 2) A first floor level slab shows excessive deterioration due to spalled cover concrete on its entire span. This slab must be re-casted. For other slabs and beams showing spalling cover concrete, they must be repaired as stated in (1) by using Polymer modified mortar.

- 3) The RCC chajjas showing excessive deflection must be carefully dismantled and re-casted or may be replaced by ferrocement chajjas which are light in weight and similar in appearance.

- 4) Waterproofing layers must be replaced in the WC's and drinking water areas showing dampness in slabs. Ferrocement Chajjas may be provided along the corridors to prevent water from coming in direct contact with the corridor slab. The external walls must be replastered by using cement mortar mixed with waterproofing compounds and repainted to match the appearance.

- 5) The existing termite shelter tubes must be removed. To prevent further ingress of termites, holes should be drilled at the junction of the plinth and wall at an angle of 45° at intervals of 1 meter. These holes should be injected with anti-termite emulsion and sealed after completion of treatment.

- 6) To avoid large separation cracks, the wall and column junction must be replastered by provision of chicken mesh to hold the plaster together.

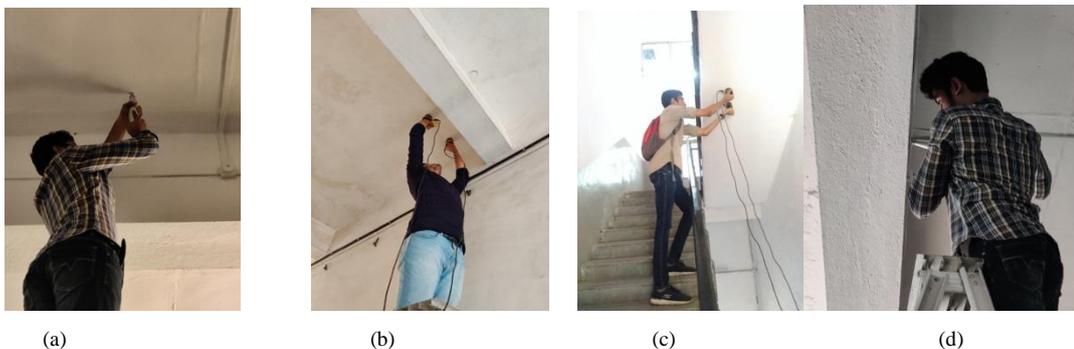
NDT was conducted on a few members on every floor. Members were selected in such a way that they represent every type of exposure condition. The findings are enlisted below: -

- 1) The average readings for all members tested by Ultrasonic Pulse velocity fall in the range of 3 – 3.5 km/sec. Thus from Table 2, IS 13311(part 1), we can conclude that the concrete is of Fair quality
- 2) The average readings for Rebound hammer test fall in the range of 30 – 40. Thus, one can conclude that the concrete is of good quality.

From the above statements, one can conclude that the concrete still retains its strength and is still homogeneous in nature.

Fig. 3. NDT test (a) Rebound hammer test on slab (b) UPV test on slab (c) UPV test on staircase slab (d) Rebound hammer test on beam
