Defect Identification in Concrete Using Active Thermography Technique

V.K.Divya¹, K.Sivasubramanian², D.Suji³P.G. Student, Department of Civil Engineering, Adithya Institute of Technology, Coimbatore, India¹Senior Scientist, CSIR-Structural Engineering Research Centre, Chennai, India²Professor and Head, Department of Civil Engineering, Adithya Institute of Technology, Coimbatore, India³

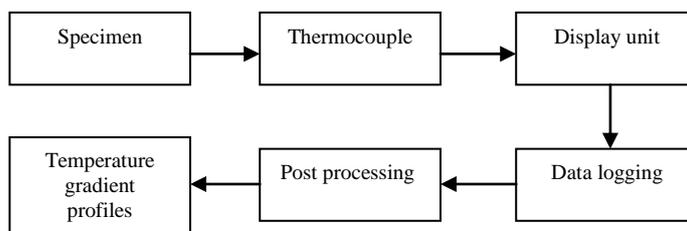
Fig. 1. Flow-chart of the experimental thermography investigation

The experimental program involves the casting of the specimen, configuring the position of the sensors, thermal display unit, data logging, post-processing and interpretation of the results. The flow-chart of the experimental program is shown in Fig. 1. In this work, a concrete specimen is cast with a predefined defect. As the present work proposes to use the thermocouples as sensors, it is proposed to adopt equally spaced sensor locations for this investigation. It is also proposed to ensure good bond between the sensing tip and the specimen surface to obtain correct temperature values. Also, the efficacy of the sensors is tested before the start of the experiment. During the experiment, the data is logged at a regular time interval for all sensor positions. This data is then post-processed for identification of the defect location.

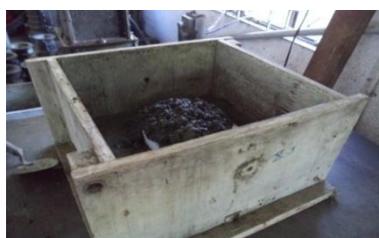
Fig. 2. Casting of the specimen

specimen has been cast with a M30 concrete. The concrete mix has been cast based on the recommendations of IS:10262-2009 [21]. The mix ratio used for making the concrete is 1:2.03:3.88 with a water-cement ratio of 0.5. The 28th day average cube compressive strength of the concrete has been found to be 43.8 MPa. The concrete specimen has been cast with a size of 0.4×0.4×0.15 m. A polystyrene of size 0.1×0.1×0.05 m has been placed in the specimen to simulate the defect. Fig. 2 shows the casting of the specimen with a predefined defect. The defect has been placed at mid-width and mid-breadth of the specimen during casting. The defect is placed such that its top surface is 50 mm from the top of the specimen.

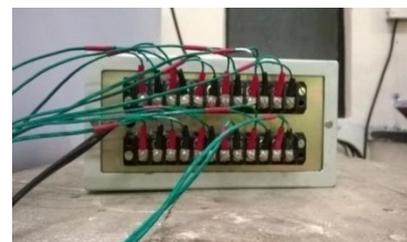
Fig. 3. Digital temperature indicator used for monitoring the temperature values (a) Typical thermocouple (b) Temperature indicator (c) Channels with connected sensors

The temperature value measured by the thermocouple is displayed by a Digital Temperature indicator. Fig. 3 (b) shows the temperature indicator with 12 channels. The selection of channels is done through rotary switch arrangement. The open end of the sensors is connected to each of the channel, as shown in Fig. 3 (c). The cost of sensor and logging device is very low when compared with infrared thermography equipment. This encourages the wide spread usage of the technique for research applications.

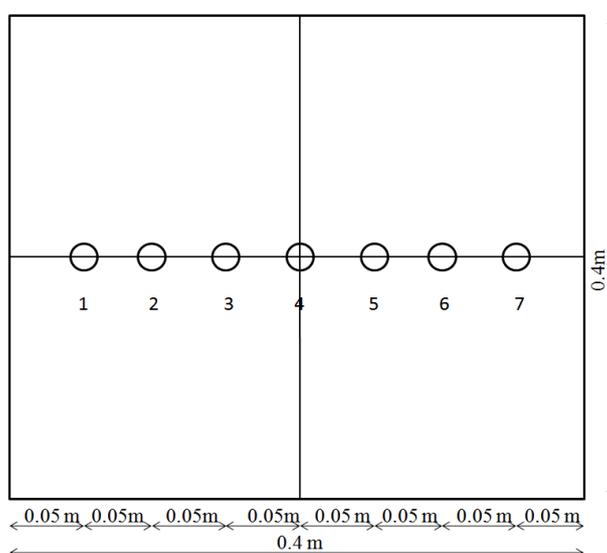
Fig. 4. Layout showing distribution of sensors

In order to determine the temperature profile of the specimen, seven thermocouples are pasted on the specimen surface in its mid-span in horizontal direction. The positioning of the sensors and their numbering are shown in Fig. 4. The thermocouples are distributed on the specimen at equal spacing. Three sensors are placed on both the left and

right side of the specimen about the midpoint, as shown in Fig. 4. In order to place the sensors, the specimen surface is cleared of dirt and then smoothened. On the smoothened surface of the specimen, the sensing junction of the thermocouple is placed. Care is taken to ensure good contact between the sensor and the specimen. Then, the sensor is pasted on the specimen using adhesive. The adhesive used here is Araldite. The other end of thermocouple which consists of two open ends is connected to the digital temperature indicator. The positive terminal of thermocouple should be connected to the positive slot of temperature indicator and the negative terminal to the negative slot.

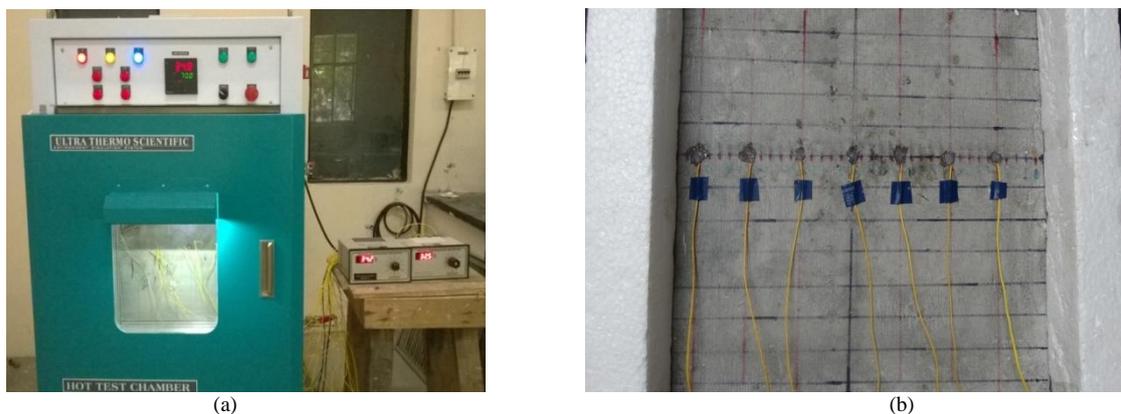
Fig. 5. Test setup for heating the specimen in the two cases (a) Case 1 Oven heating (b) Case 2 Solar heating

The first part of the study focuses on using the oven as the source of heat. The temperature range of oven used here is between room temperature and 180°C. The oven has a space of 0.6×0.6×0.6 m to place the specimen. The specimen size is fixed keeping in mind the oven size. In this method, the specimen is heated by keeping the specimen inside an oven. Fig. 5 (a) shows the test setup used for the case 1 experiment. During the experiment, the specimen is heated on the top surface. The temperature measurement is made directly from the top surface of the concrete specimen.

The second case investigates the applicability of the solar heat for the non-destructive evaluation. In this method, the specimen is heated using natural solar heat. The specimen is insulated with polystyrene pieces on all the four edges, as shown in Fig. 5 (b). The edges on the top of the specimen are also insulated with polystyrene pieces to avoid rapid heating at the edges, as in Fig. 5 (b). The sensors are numbered sequentially from left to right to facilitate in recording the values.

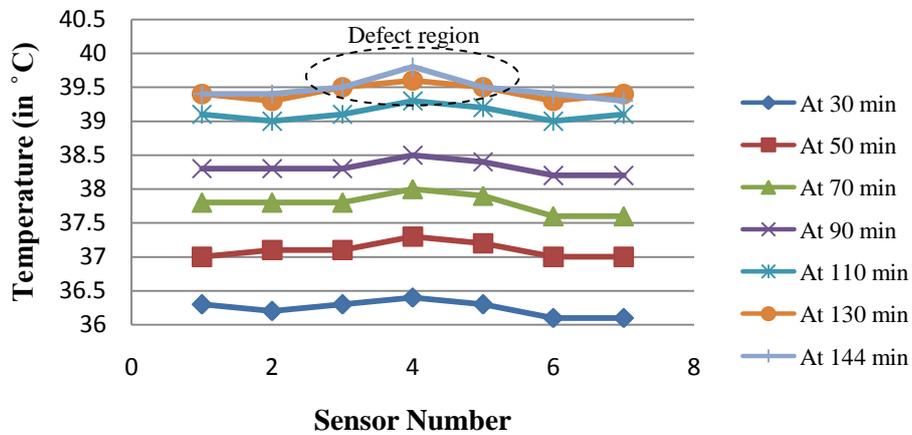
Fig. 6. Temperature distribution at different locations of sensors during ideal heating

In the first part of the study, an oven has been considered as the heating source. This artificial heating source is used to check the possibility of identifying defects in concrete. During the experiment, the specimen is placed in the oven and a constant heat is applied on the top surface of the specimen for a particular time period. Fig. 6 shows the plot of temperature at various sensor locations on the specimen for different heating periods in the oven. It can be observed from the temperatures of sensors 1, 2, 6 and 7 that a uniform heating has been applied on the specimen. This

experiment simulates an ideal heating environment so that defect identification is possible without ambiguity. From Fig. 6, it can be observed that the temperature values at sensor locations 3, 4, and 5 are slightly higher than the other sensor values. Since a nearly uniform heat source has been used for the study, it can be interpreted that this variation in the temperature values is due to the presence of a defect below those locations. The sensors are placed 50mm apart as shown in Fig. 4. Thus, it can be interpreted that the defect is approximately 100mm wide. Also, it can be observed that the sensor at the middle of the defect (sensor 4) records much higher values than the sensors over the edge of the defect (sensors 3 and 5).

Comparing the results from Fig. 6 and Fig. 8, it can be observed that the temperature distribution at an instant differs based on the heating source. With an ideal heating source, it is possible to arrive at clear and unambiguous results which would help in easy interpretation and identification of the defect location. While applying the solar heat, many influencing factors participate and the higher heat energy from the sun has led to the increased temperature values in sensors 3, 4 and 5 even at the 30 minute interval (as shown in Fig. 8). It is also observed that the higher temperature values in sensors 3 to 5 have influenced sensors 2 and 6 to record higher values (as shown in Fig. 8). Because of these reasons the identification of the defects size becomes difficult. Also, sensors 1 and 7 do not record same temperature values in case 2. This is caused by the orientation of the sun with respect to the normal to the specimen's top surface. With these observations in the mind, the temperature time histories shall be compared. From Fig. 7 and Fig. 9, it can be observed that the temperatures recorded above the defect are relatively higher when compared to the other locations. However, because of the uncontrolled heating while using the natural heating, the difference between the node 3 and node 6 is not appreciable. Even then, the temperature time histories of the defect region could be differentiated from the other region in Fig. 9. Thus, the applicability of thermography technique for defect identification in concrete seems encouraging. However, the use of a uniform heating source is found to provide encouraging observations.

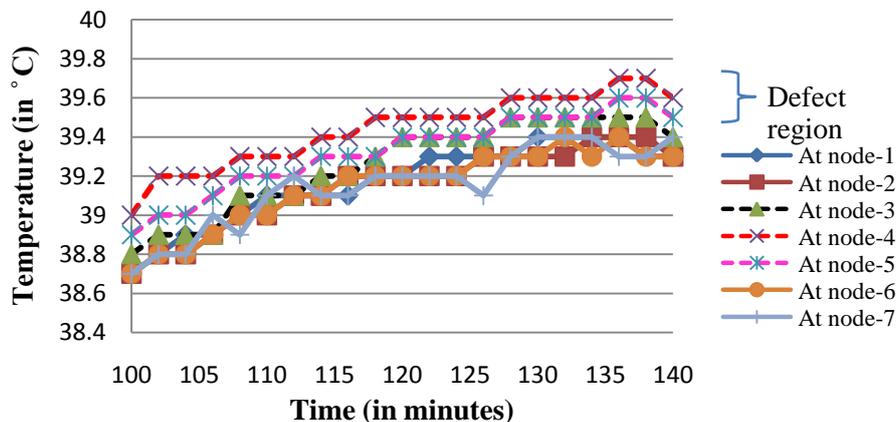
Fig. 7. Temperature distribution at various nodes during different heating periods

Similarly, the temperature time history data is analysed for observations related to defect identifications. Fig. 7 shows the plot of temperature profile at each node on the specimen where the sensors are placed. From the graph, it can be observed that the temperature profile of the nodes 3, 4 and 5 are higher when compared to the profile of other nodes. This demonstrates that the temperature profile varies over the region of defect. In the defect region, the accumulation of heat energy is observed to be relatively higher when compared to other regions. The specimen is heated for a period of about 144 minutes. It has been observed that the temperature values increase with sustained heating. The temperature variations over the defect areas are observable after heating for a period of about 80 minutes. Hence, the graph is plotted for a 40 minutes period of time starting from 100 minutes.

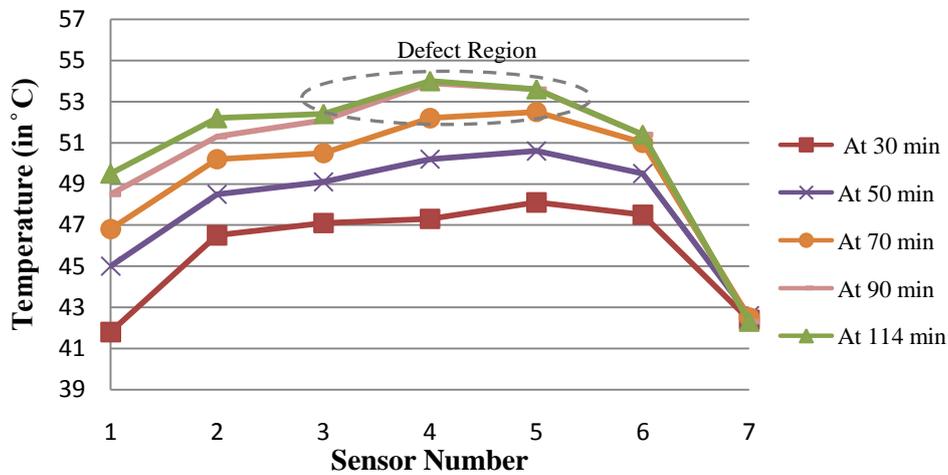
Fig. 8. Temperature distribution at various positions of sensors

In the second case, the results obtained by heating the specimen under sunlight are discussed. Fig. 8 shows the plot of temperature at various sensor locations on the specimen during different heating periods under sunlight. From the results, it is observed that temperature increases slightly over the nodes where 3rd, 4th and 5th sensors are placed whereas in the other sensors the temperature values are relatively smaller. In addition, the temperature values in sensors 2 and 6 are also found to be relatively higher when compared to sensors 1 and 7. Hence, the interpretation of the size of the defect would be difficult from these results.

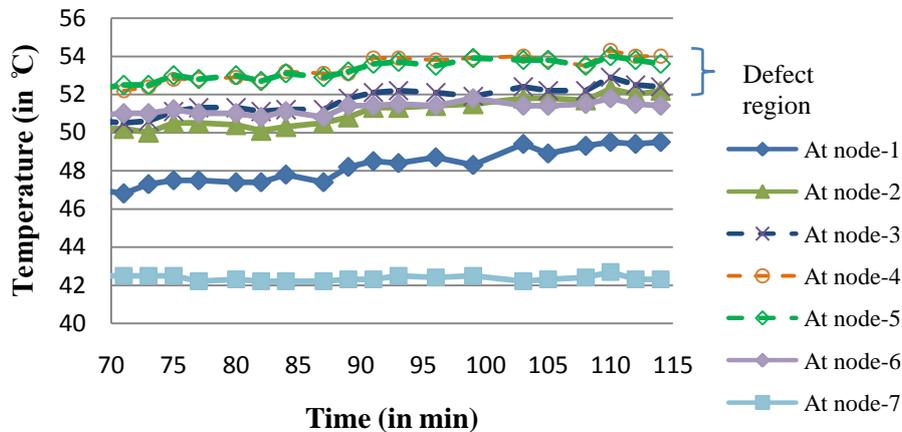
Fig. 9. Temperature distribution at various nodes at different time periods

Fig. 9 shows the plot of temperature time histories at all nodes of the specimen where the sensors are placed. From the graph, it is clear that the temperature profiles of the nodes 3, 4 and 5 are consistently higher when compared to the profile of other nodes. Temperature in these areas increases rapidly when compared to other areas as the time of heating increases. From the temperature profile, the areas of defect can be identified.
