# Performance Evaluation and Safety Analysis of Pedestrians at Vytilla Junction, Kochi, Kerala

**ABSTRACT:** Pedestrians are extremely vulnerable in crashes with the faster moving and much more massive motor vehicles. Circulation of pedestrian is of vital importance's to the modern metropolis, but the paradox here is that though meant for human travel, these roads hardly provide any quality space for those who are without vehicles (well known as pedestrian). Due to the ambiguous position of non-motorized travel in an urban transportation system, the transportation conditions for non-motorized travel are getting worse in cities, which illustrate the urgent need for the improvement for same. A proper of understanding of pedestrian needs and characteristics and factors that contribute to pedestrian crashes is essential for the proper design and operation of roadways and pedestrian facilities. The study is confined in identifying the pedestrian and vehicular conflict at the Vytilla junction and the problems faced by the pedestrians in the concerned area. The safety analysis of the pedestrians at the junction is done by PV<sup>2</sup> analysis and by determining the Level of Service (L

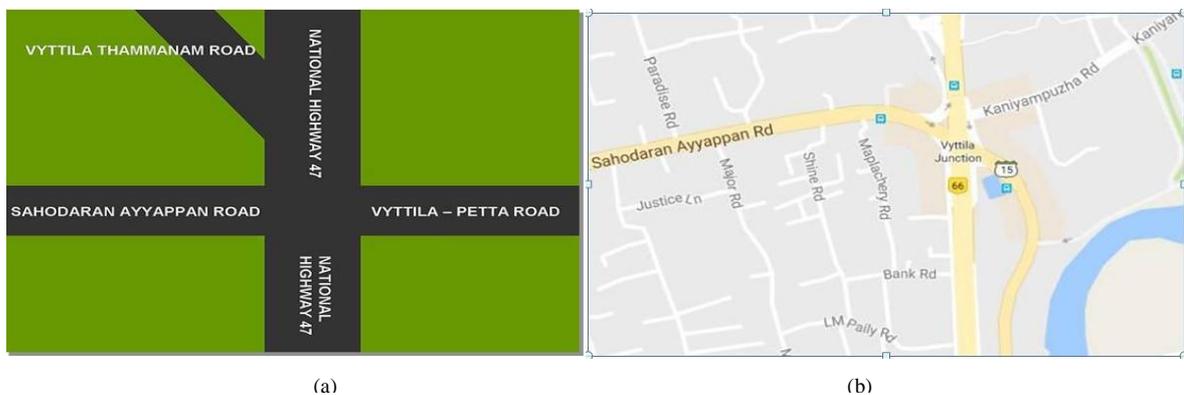
Fig. 1. (a) A schematic map of the Vytilla junction (b) Google map image of the Vytilla junction

Figure 1 (a) and (b) shows a schematic and google map image of the junction while Figure 2 shows a photograph of the study area.

Vytilla is an intersection in the city of Kochi, in the state of Kerala. It is one of the largest as well as the busiest intersections in Kerala. This node intersects the main North-South artery of the state, namely NH-47. Vytilla hosts the Kochi Mobility Hub, which converges different ways of surface transport to the city onto a single node.
