Structural Health Monitoring Of Steel Sections Using EMI Technique

Salma Ansari, Dr.S.K Hirde

PG Student, Structural Engineering, Government College of Engineering, Amravati, Maharashtra, India

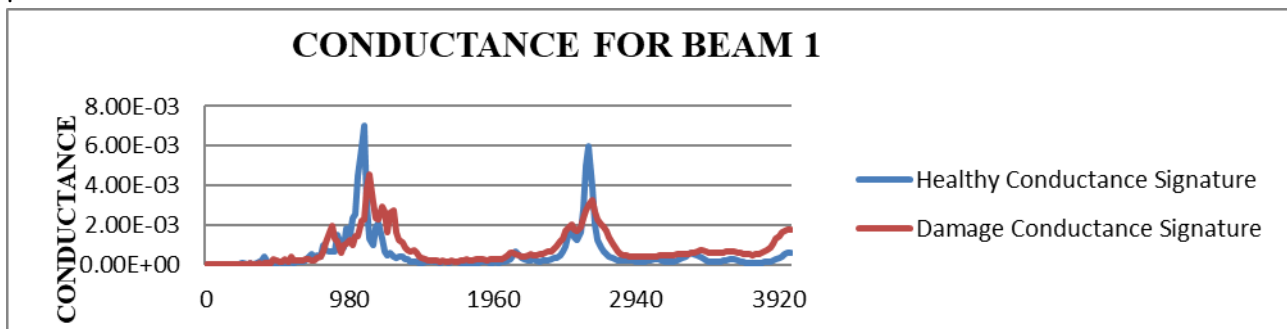
Fig.1: Conductance for Beam 1 by PZT patch 1 its comparison with damage

The beam was subjected to frequency range of 30 kHz – 400 kHz. In this range, the corresponding conductance and susceptance values were recorded by LCR meter. Then the corresponding admittance was calculated. Firstly, healthy signature of intact specimen was taken then the damage was introduced in the beam and corresponding damaged signature was taken. This procedure is repeated for all the beams. The conductance, susceptance and RMSD graphs are then plotted. For beam 1 all these plots are as shown in respective figures below.

In the experimental protocol, all specimens underwent a rigorous regimen of induced damages, with particular emphasis on the application of various stressors to assess their structural integrity. Notably, a centrally applied load was employed on beam 1, serving as a benchmark for subsequent analyses. Comparative evaluations between the readings obtained from pristine and impaired specimens underscored the heightened sensitivity of conductance measurements over susceptance, illuminating its efficacy across the entire spectrum of specimens examined. Focusing specifically on beams 2 and 3, corrosion was deliberately induced to simulate real-world scenarios. Beam 2 received a protective epoxy coating, while beam 3 remained untreated, serving as a control. Conductance analyses unveiled that the untreated beam exhibited discernibly heightened levels of structural degradation, as evidenced by a noteworthy root mean square deviation (RMSD) discrepancy of 0.85. Furthermore, even in instances where minimal damages were intentionally introduced to specimens 4 and 5, conductance emerged as a dependable diagnostic tool, demonstrating its robustness and reliability in detecting subtle structural alterations. This underscores the versatility and efficacy of conductance as a sensitive indicator of structural integrity in diverse experimental settings.

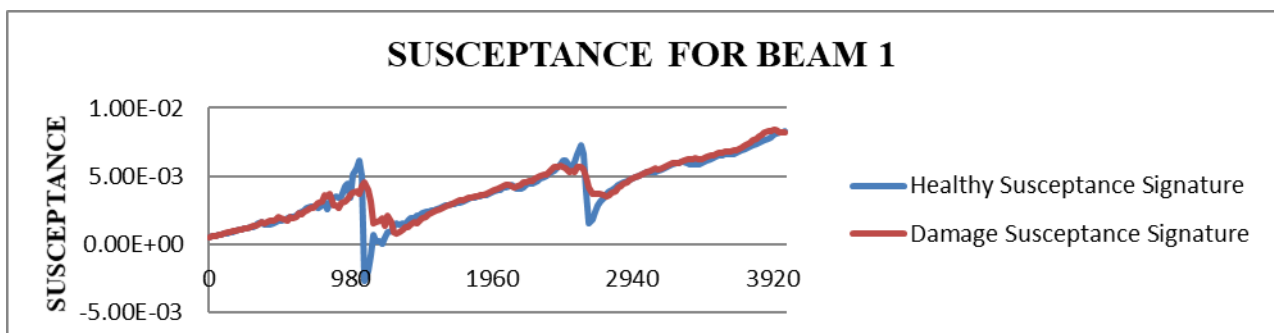
Fig.2: Susceptance for Beam 1 by PZT patch 1 its comparison with damaged

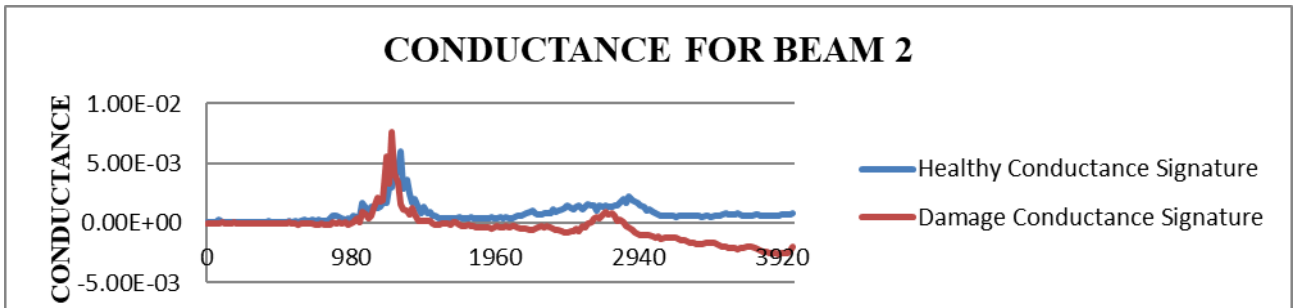
Fig.3: Conductance for Beam 2 by PZT patch its comparison with damaged

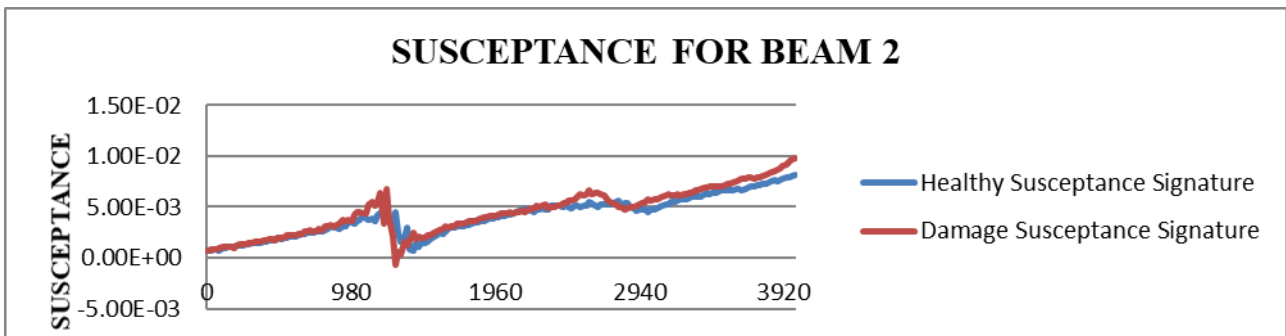
Fig.4: Susceptance for Beam 2 by PZT patch its comparison with damaged

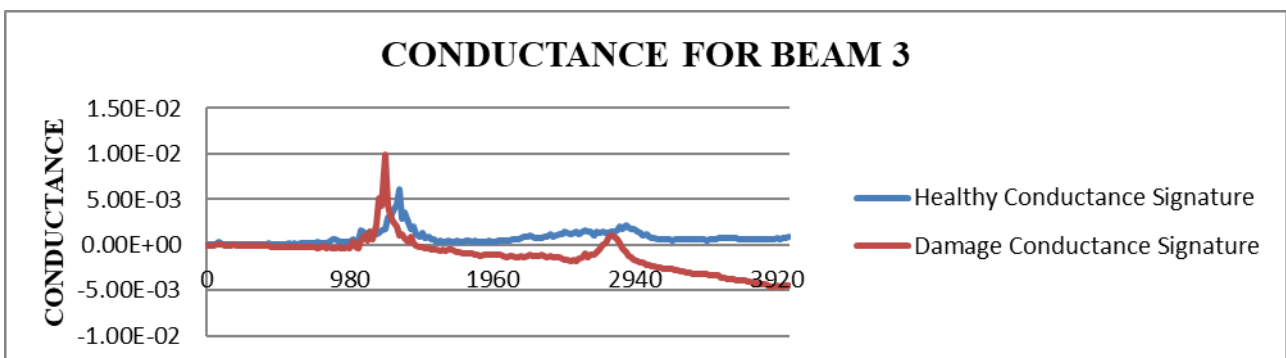
Fig 5: Conductance for Beam 3 by PZT patch its comparison with damaged

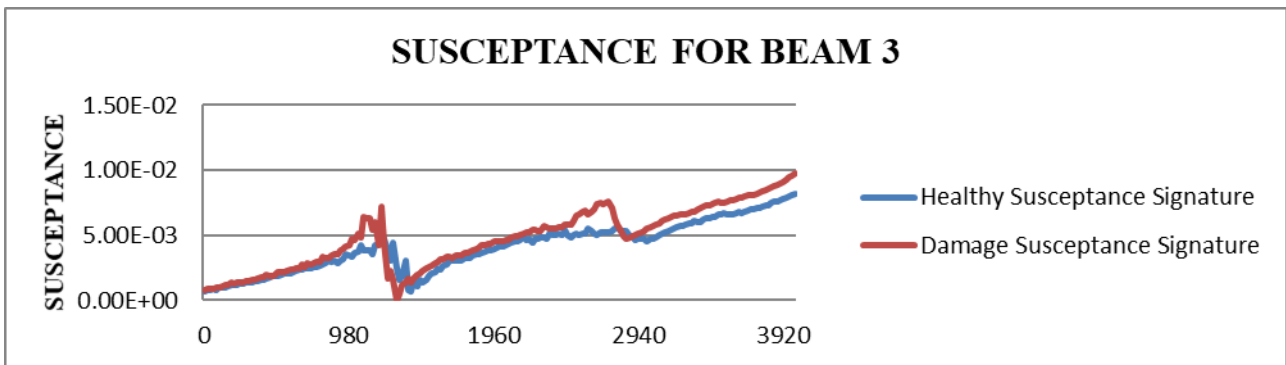
Fig.6: Susceptance for Beam 3 by PZT patch its comparison with damaged

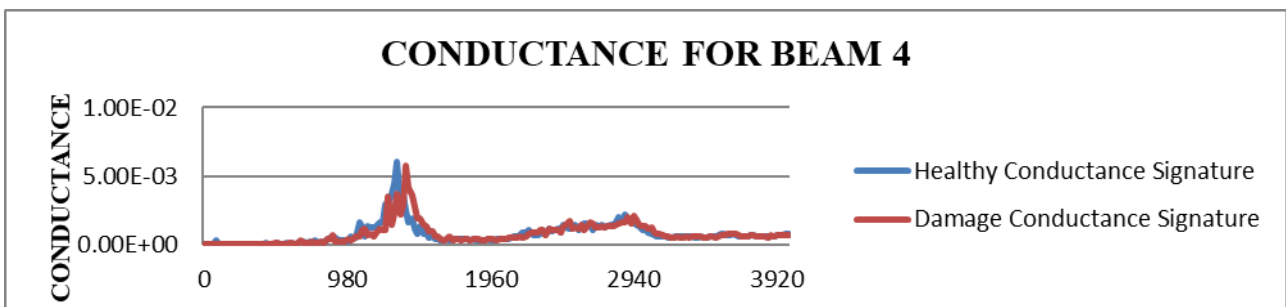
Fig.7: Conductance for Beam 4 by PZT patch 1 its comparison with damaged

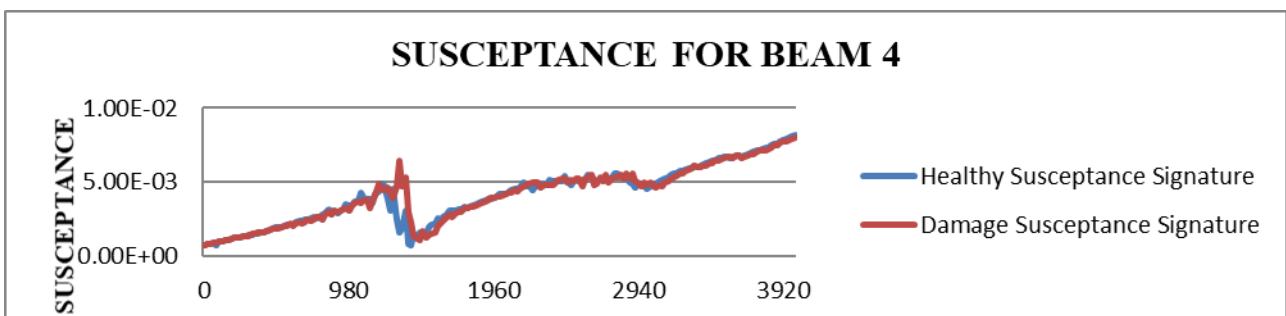
Fig.8: Susceptance for Beam 4 by PZT patch 1 its comparison with damaged

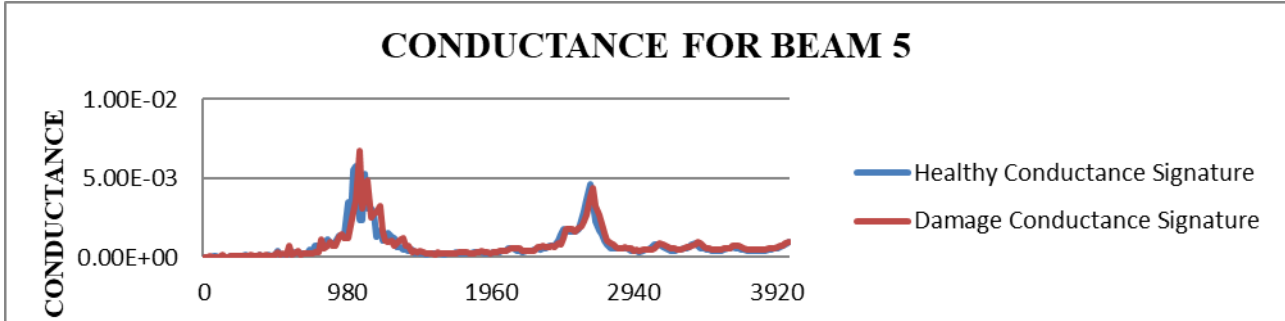
Fig.9: Conductance for Beam 5 by PZT patch 1 its comparison with damaged

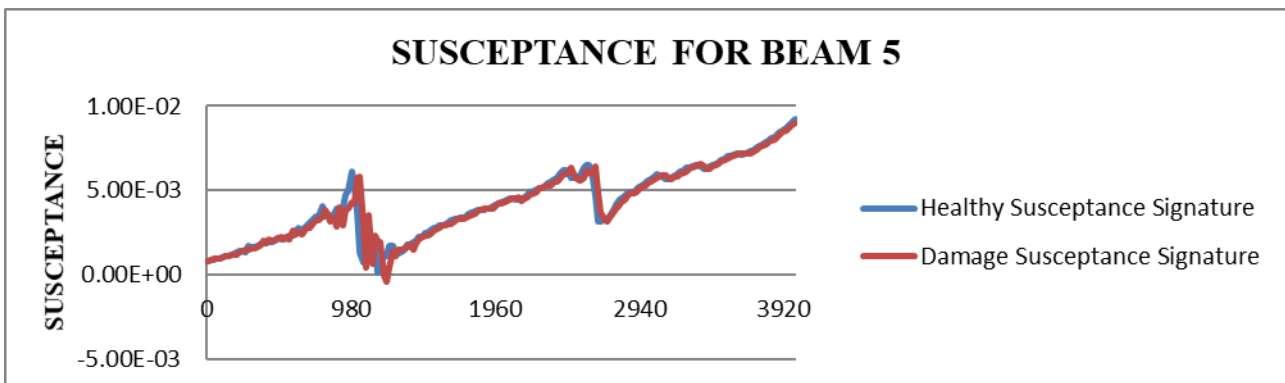
Fig.10: Susceptance for Beam 5 by PZT patch 1 its comparison with damaged
