# Review on Analysis of Irregular Structures under Earthquake Load (Vertical and Horizontal Irregularity)

**ABSTRACT:** Previous earthquakes in India have discovered that most of the buildings aren't designed to be earthquake resistant. In general, buildings are designed taking into account just the gravity loads. Furthermore, the present look seismic codes are not completely practiced while developing a building. a thus a thus higher degree of damage might be expected during an earthquake in case the seismic resistance of the structure is insufficient. The existing work describes the various reinforced concrete (RC) frames having various irregularities but with same dimensions which are analyzed to study the behaviour of theirs when put through seismic lateral loads. All of the frames were analyzed with the same strategy as mentioned in Is 1893-Part-1:2002. By the end result, it's been interpreted the base frame (regular) evolves least story drifts while the structure with floating columns shows maximum storey drifts on the soft story levels. Hence, this's very vulnerable to damages under this particular type of loading. The structures with irregularities also proved unsatisfacto

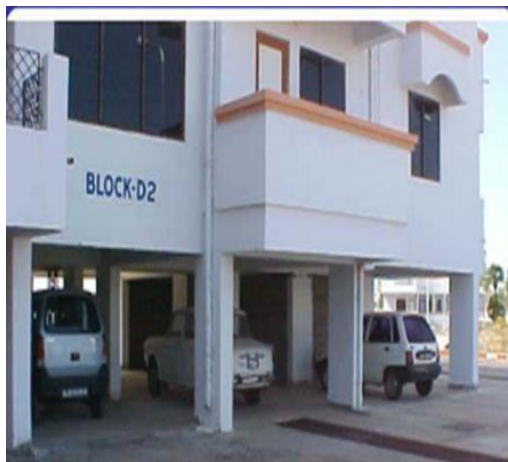
This kind of irregularities arises because of unexpected reduction of strength or stiffness in a specific storey. For extremely high seismic zone area, irregularity in building is probably a great problem to an excellent structural engineer. A lot of vertical irregular buildings occur in modern-day urban infrastructures. Among them Open ground storey as well as stepped kinds of structures are extremely typical in Urban India. A common Open Ground Storey and a Stepped irregular framed building are revealed in Figure 1.1.

**Figure 1.1 Vertically irregular buildings**
